# Mercury Alert

## Antique Mirrors

Elemental Services and Consulting, Inc. (ESCO) was retained to obtain mercury vapor concentrations from an antique dresser with attached mirror. The owner of the dresser upon learning that mercury was used in making mirrors decades ago was concerned that mercury vapor was contaminating their home.

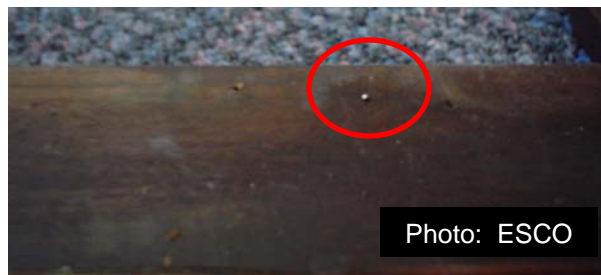
The owners attempted to remove the mirror from the frame in order to replace it and discovered a bead of mercury during the removal process (see photo).

Mercury vapor concentrations following the recovery of the mercury were 0.9  $\mu\text{g}/\text{m}^3$  in the breathing zone, but rapidly dissipated with ventilation to outdoors. The carpeted floor indicated mercury vapor concentrations of 0.5  $\mu\text{g}/\text{m}^3$  – 0.8  $\mu\text{g}/\text{m}^3$  for nearly 2 hours until ventilation to outdoors was complete. Mercury

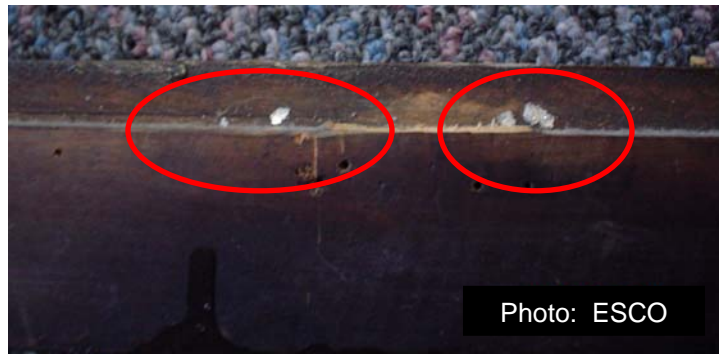
Additionally, flakes of the silver backing were observed around the bevel of the wood holding the mirror in place. Several flakes of silver backing were discovered behind the dresser in the bedroom (see following photograph).

The mercury vapor concentration in the area of these flakes was  $> 100 \mu\text{g}/\text{m}^3$ .

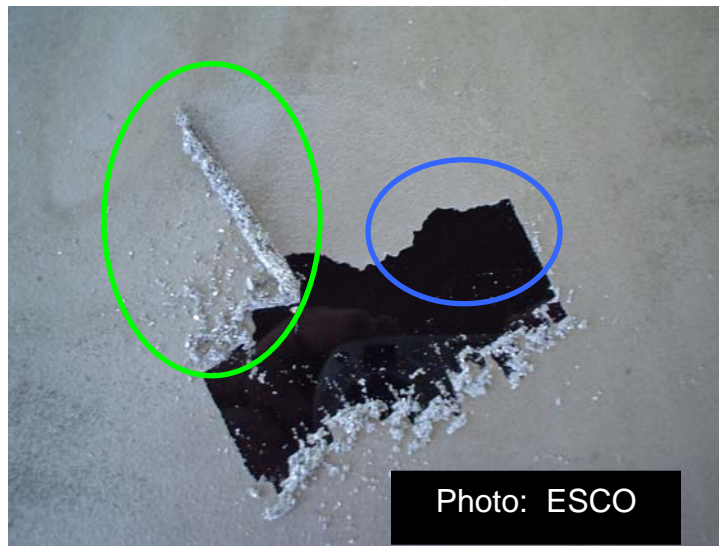
The following photograph shows how the tin amalgam behaves when scraped off the glass. Note how there are crisp edges at the leading edge (blue). Also note when the removed amalgam is pushed together, it binds quite readily (green).

Mercury vapor concentrations of this amalgam were  $>100 \mu\text{g}/\text{m}^3$ .

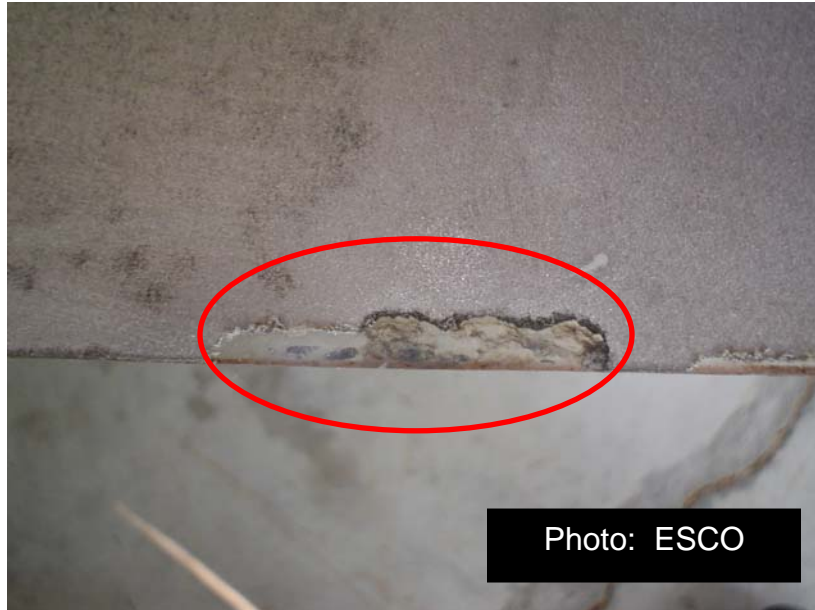
The following photograph shows the detail where braces held the mirror within the frame. It is believed that these areas are where the flakes came from that were observed in the frame and on the floor below the dresser.
